**350 Windsor Park  
Havertown, Pa 19083**

**January 22, 2016**

**Prepared for: Bill & Andrea Devenney**

RE: 350 Windsor Park  
Havertown, Pa 19083  
Report #16011884

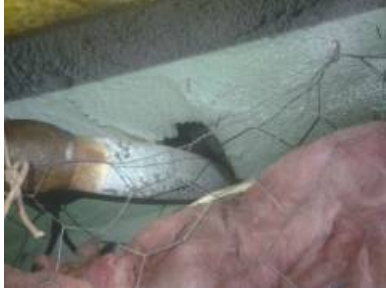
## Firewall Separation

**Safety Concern** - Fire separation wall is deteriorated. Openings in the ceilings, no matter how small, compromise the fire rating. This is a safety hazard. General repairs are needed that should easily be performed by a qualified handy person.

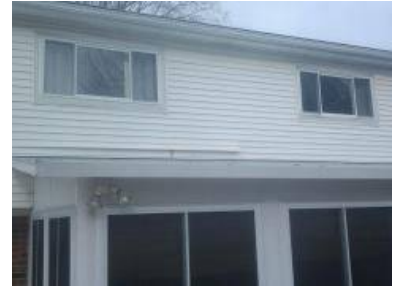
**Maintenance Advised** - The following conditions were observed at the rear exterior surface areas: Siding is loose. General repairs are needed that should easily be performed by a qualified handy person.

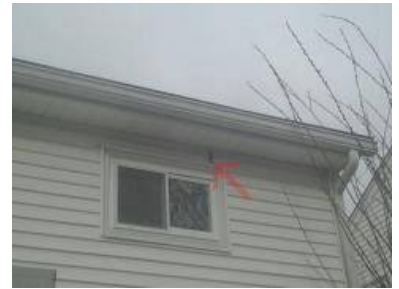
**Maintenance Advised** - The following conditions were observed at the rear exterior surface areas: Siding is improperly installed. Gaps in siding can allow water intrusion behind the surfaces. General repairs are needed that should easily be performed by a qualified handy person.

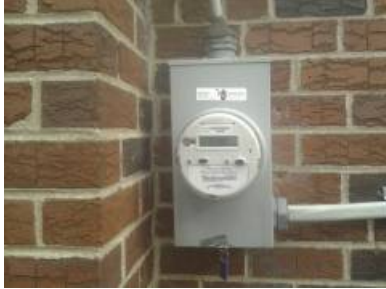
**Service Type & Rating:** Overhead. Service conductors are aluminum. Service rating is 200 amp capacity. 220 volt supply.

**Main Disconnect Location:** Main panel.

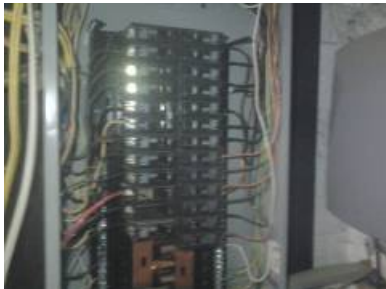
**Main Panel:** Located in the basement. Main shut off is installed at this panel. Panel has a 200 amp rating.

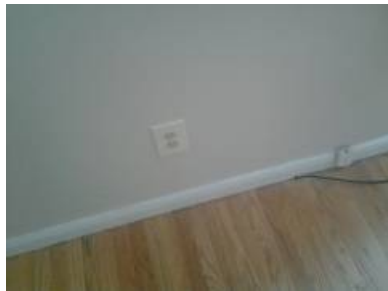
### Interior Receptacles

**Deficiencies** - The following conditions were observed at the master and front right bedroom receptacle(s): Test indicates improper connections, there is 3 prong type outlets not grounded (open ground). Grounding is a safety feature which is part of the electrical system and should not be defeated. Grounding is the act of connecting something to ground (earth) so it has zero electrical potential. Grounding also refers to the earth grounding system that protects against lightning and helps eliminate static charges. Where testing of receptacles shows a "no ground" condition the problem generally can be traced to a loose wire in the receptacle box or in the electrical panel. A licensed electrician is best suited to locate and correct any loose ground wiring.

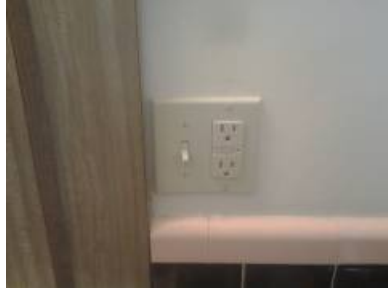
### Ground Fault Circuit Interrupters (gfcis)

**Safety Concern** - The following conditions were observed at the master bathroom GFCI reset receptacle: GFCI protected receptacle will not trip and power stays constant (no response when test button is pressed). Improper test results are found at an intended protected circuit, suspect improper wiring within in the circuit. A qualified electrician should be called to further evaluate and perform corrections as needed.

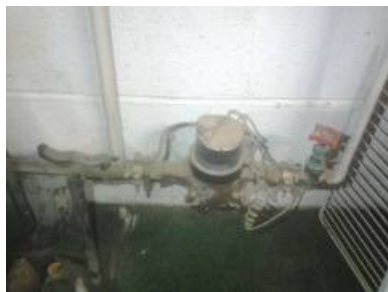
**Water Distribution Piping:** Copper.

**Drainage Pipes/Lines:** Cast iron.

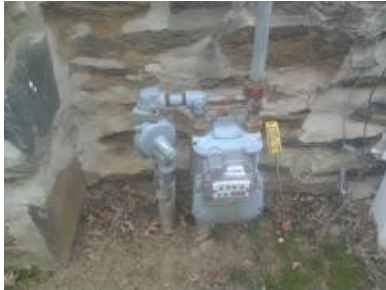
**Main Fuel Shut Off Location:** Valve is near the fuel meter.  
**Fuel Type:** Natural gas.  
**Fuel Piping:** Iron pipes.

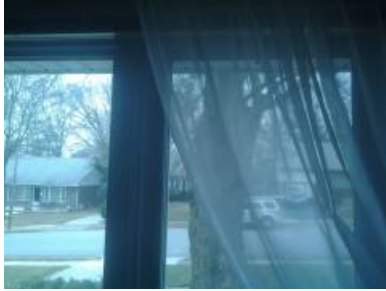
### Window Frames & Hardware

**Maintenance Advised** - The following conditions were observed at the living room window(s): Hardware is damaged. Minor adjustments are anticipated to restore proper operation. Minor repairs that are needed can easily be accomplished by a qualified handy person.

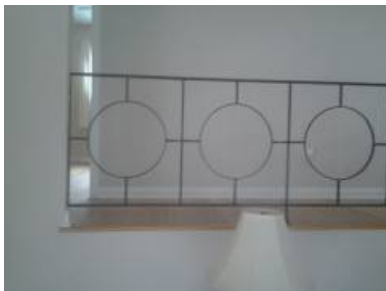
### Interior Guard Rails

**Maintenance Advised** - The following conditions were observed at the main staircase guardrail: Guardrails are unsafe. Gaps should be spaced no more than 4" apart. General repairs are needed that should easily be performed by a qualified handy person.

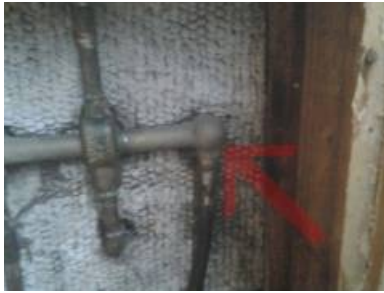
### **Tubs**

**Deficiencies** - The following conditions were observed in the # 2 bathroom(s): Tub faucet is dripping. Water damage will worsen without immediate plumbing repairs performed. A qualified plumber should further evaluate and replace components as needed.

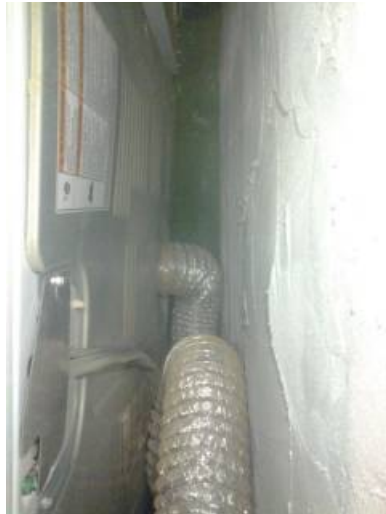
#### **Dryer Hookups**

**Safety Concern** - Dryer vent is improperly installed. Shorten vent. Minor repairs that are needed can easily be accomplished by a qualified handy person.
